Aircraft Accident Summary Résumé d'accident d'aéronef

12 January 2006

TYPE: CH146475 Griffon
LOCATION: Goose Bay, Labrador
DATE: 17 September 2003

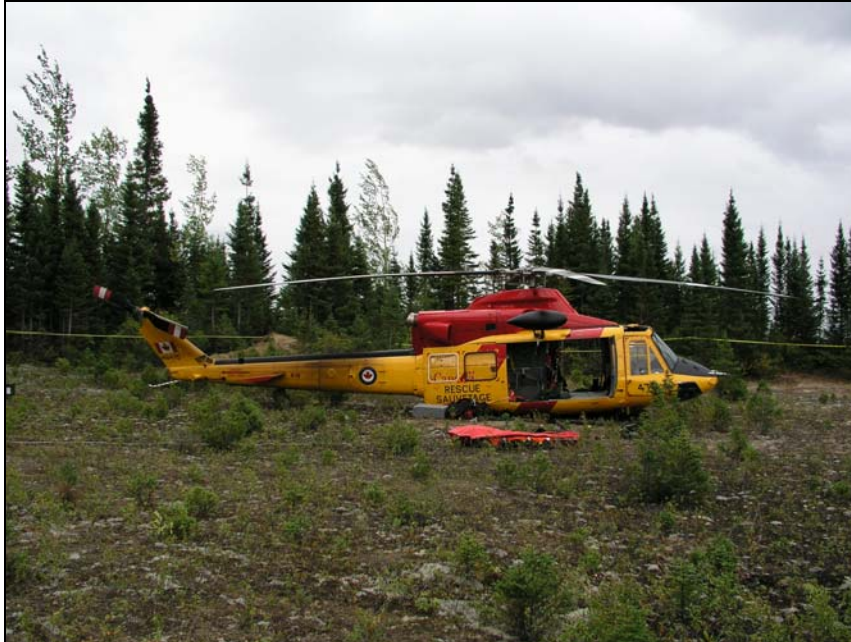
In this accident, control of the hoist had just been transferred from the flight engineer to the non-flying pilot when the aircraft began to sink and yaw to the right. The flying pilot initiated actions for a suspected tail rotor failure that included rolling both throttles to idle and entering auto-rotation. The aircraft landed in a flat attitude and suffered "B" category damage. All of the crewmembers on board the aircraft suffered injuries due to ground impact forces (1 major and 3 minor injuries).

The investigation revealed that there were three main contributing factors to this accident. The first factor was that the non-flying pilot caused a power reduction by toggling the 'beep' switch instead of the intended hoist over-ride switch. The second factor was that the flying pilot misinterpreted a 'beep' down as a tail rotor failure, and finally, the last factor was an ineffective auto-rotation.

Recommendations include a re-design of the 'beep' and hoist over-ride switches to reduce the possibility of mis-identification of the switches and inadvertent beep switch activation. It is also recommended that simulator training be enhanced to include more, and varied, engine malfunctions from the hover. And finally, it is recommended that the realism and visuals of the CH-146 simulator be upgraded in the zero to fifty-foot range to increase the realism in the landing phase during emergency training in the simulator.
